A STUDY OF THE USE OF VIBRATION AND  
STRESS WAVE SENSING FOR THE DETECTION  
OF BEARING FAILURE

ENGINEERING REPORT NO. 75-18 C

National Aeronautics and Space Adminis-  
tration, George C. Marshall, Space Flight  
Center, Huntsville, Alabama 35812

NASA Contract NAS8-29916

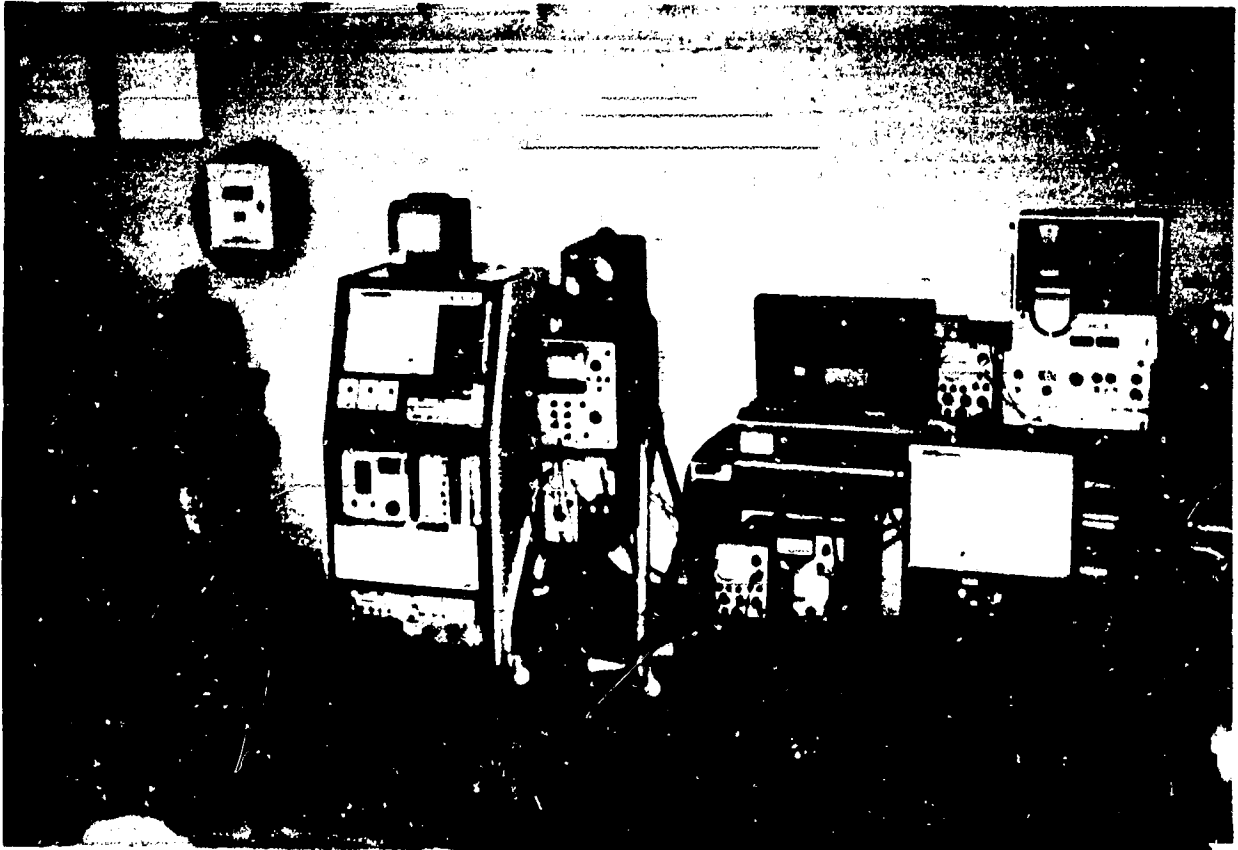
Figure 20 - Bearing test machine with equipment used to record and process the data from the bearing tests.

Two different instrumentation setups were used to condition the signals from the sensors, to provide recordings, and to process and analyse the data. One system was used for all data below 200 kHz. This was for use with the 2236 and 6230M8 sensors and is shown in a block diagram in Figure 18. The other system was for use above 100 kHz and is shown in a block diagram in Figure 19. Data was taken with this using the D9202 sensor. Figure 20 is a photograph of the instrumentation assembled for the bearing tests.
